**JTAGG II Brush Seal Test Results**

**33rd AIAA/ASME/SAE/ASEE  
Joint Propulsion Conference and Exhibit  
July 6-9, 1997 / Seattle, WA**

NASA  
Technical Memorandum 107448

## JTAGG II Brush Seal Test Results

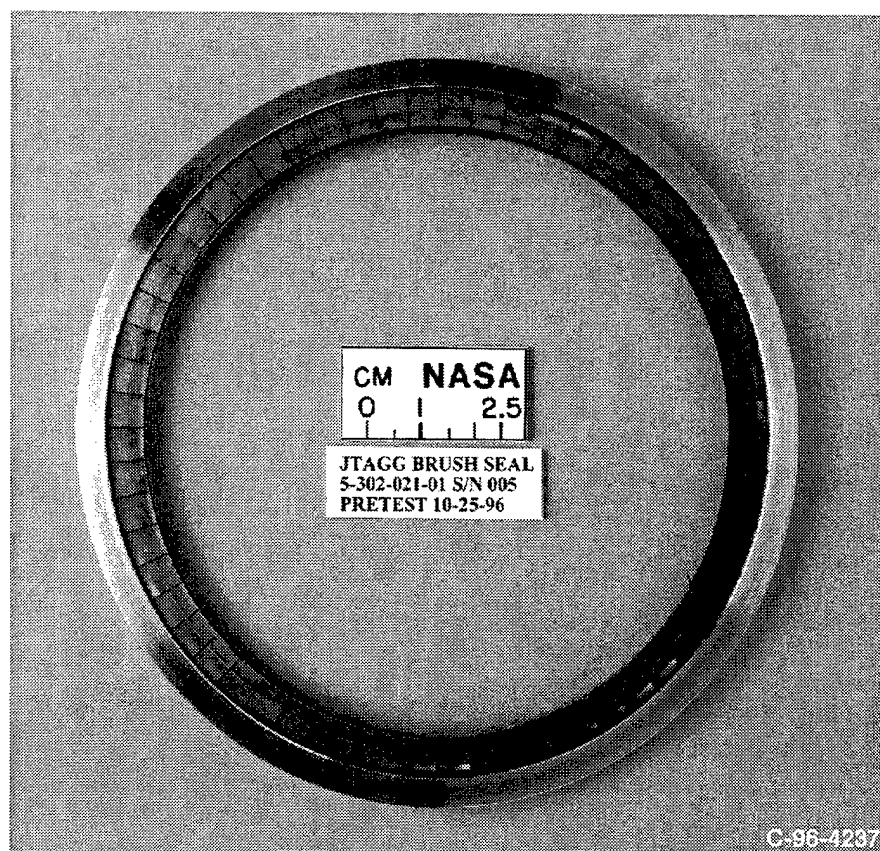
Figure 12.—Advanced low hysteresis brush seal.

This problem was discussed with the seal vendor EG&G Sealol. A new set of seals (S/N 5 and 7), which incorporated their latest technology, was procured and tested later in the program (before the endurance test). These seals had two features: (1) the low pressure side plate was relieved where it contacts the bristles (similar to the conventional low hysteresis design), and (2) a thin deflector plate was inserted between the high pressure side plate and the bristles. Elements of this design are covered under U.S. patent number 5401036, but the details of some additional features proprietary to EG & G Sealol are not available. These features have shown reduction in seal hysteresis in rig testing at EG&G Sealol.<sup>1</sup> Figure 2 shows a conceptual view of the advanced test seal. A photograph of the advanced low hysteresis seal is shown in Fig. 12.
